SAFETY ALERT

ASBESTOS CONTAINING HRC FUSES

26/07/16 | Issue SA 68-16

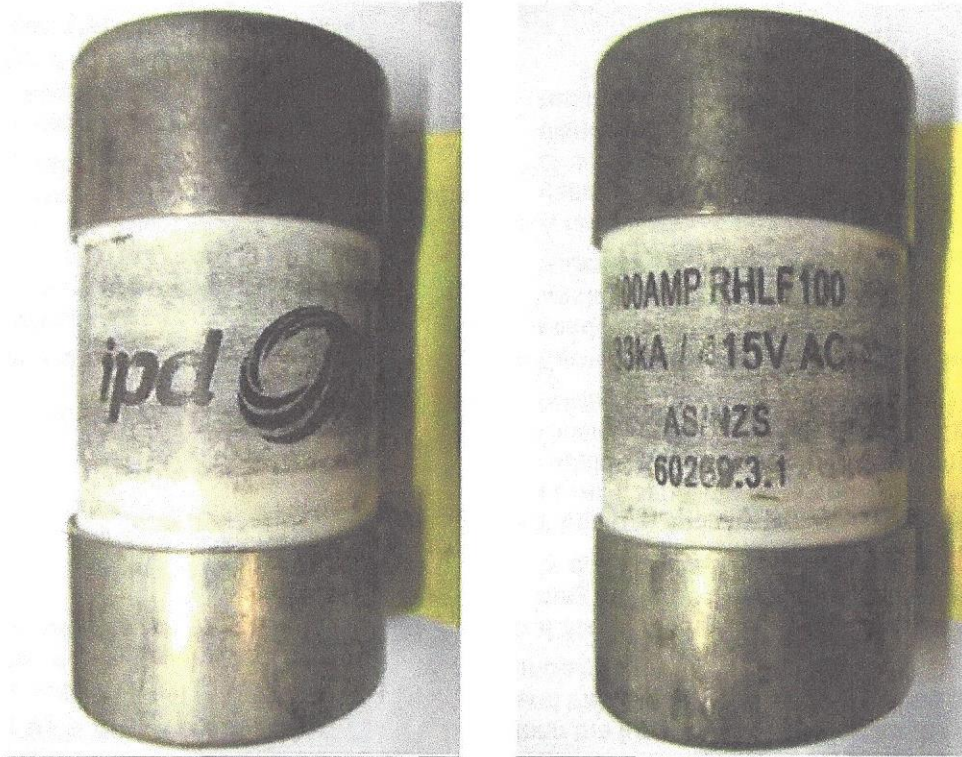
An ipd brand of HRC fuse and example markings

Manufacturer: ipd

Model: RHLF100

Details: 33kA/415V, AC, AS/NZS 60269.3.1, 5.07.10

Result: Chrysotile (white asbestos) detected

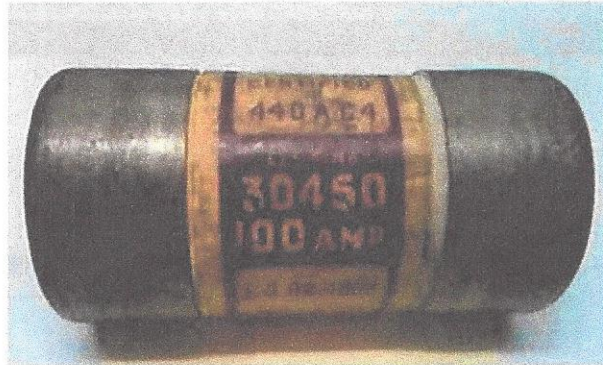
Manufacturer: Henley

Model: List No. 30450

Details: 440A.C.4 BS88:1952, FF1.70 Pat.No. 58:269

Result: Chrysotile (white asbestos) detected

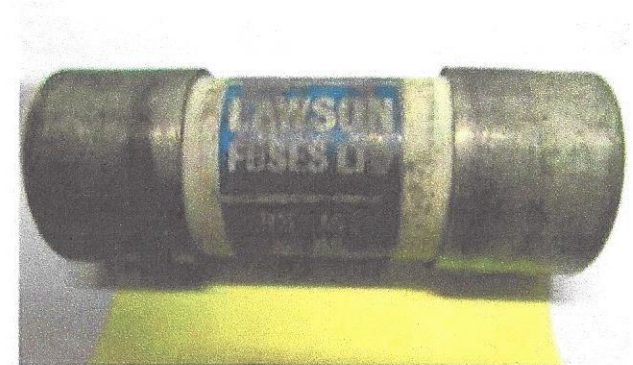
Manufacturer: Lawson Fuses Ltd

Model: ME

Details: BA1361, BS88, 415Vac, 80 ASTA cert01

Result: Chrysotile (white asbestos) detected

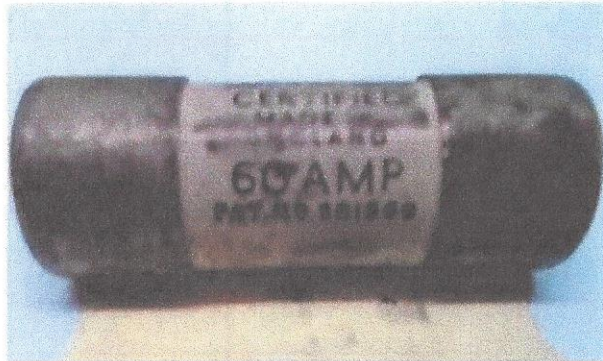
Manufacturer: Henley

Model: List No. 30348

Details: 440ac 4, B.S.88:1952, Pat. No. 581269

Result: Chrysotile (white asbestos) detected

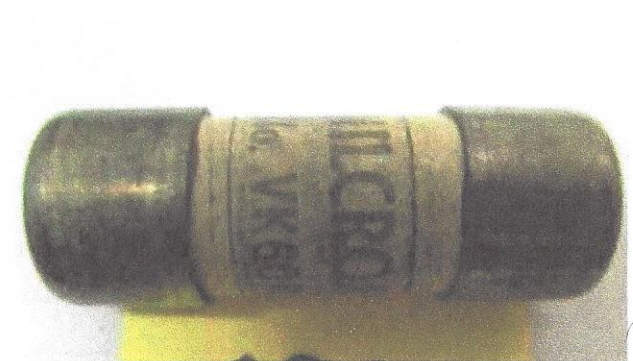
Manufacturer: Nilcrom

Model: No VK60/R

Details: 440V AC5

Result: Chrysotile (white asbestos) detected
